Water Resources Department- Resilient Kerala Program- Integrated River Basin Management Plan for Greater Pamba Basin- Approved- Orders issued.

G.O.(Rt)No.504/2025/WRD Dated, Thiruvananthapuram, 22-05-2025

The Integrated River Basin Management (IRBM) Plan for the Greater Pamba Basin is a comprehensive framework designed to address Kerala's pressing challenges of flooding, water insecurity, and ecological degradation. Anchored in scientific analysis and participatory governance, the plan responds to the catastrophic 2018 Kerala floods, which caused unprecedented devastation, including loss of lives, destruction of crops, and critical damage to water infrastructure. The floods underscored systemic vulnerabilities, such as silt-clogged irrigation canals, collapsed hydraulic structures (sluice gates, check dams), and overwhelmed urban drainage systems. Coastal protection breaches also led to saltwater intrusion in the ecologically sensitive Vembanad Lake. These impacts catalysed the state's commitment to rebuilding sustainably through Integrated Water Resources Management (IWRM), guided by the "Navakeralam" vision of equitable development.

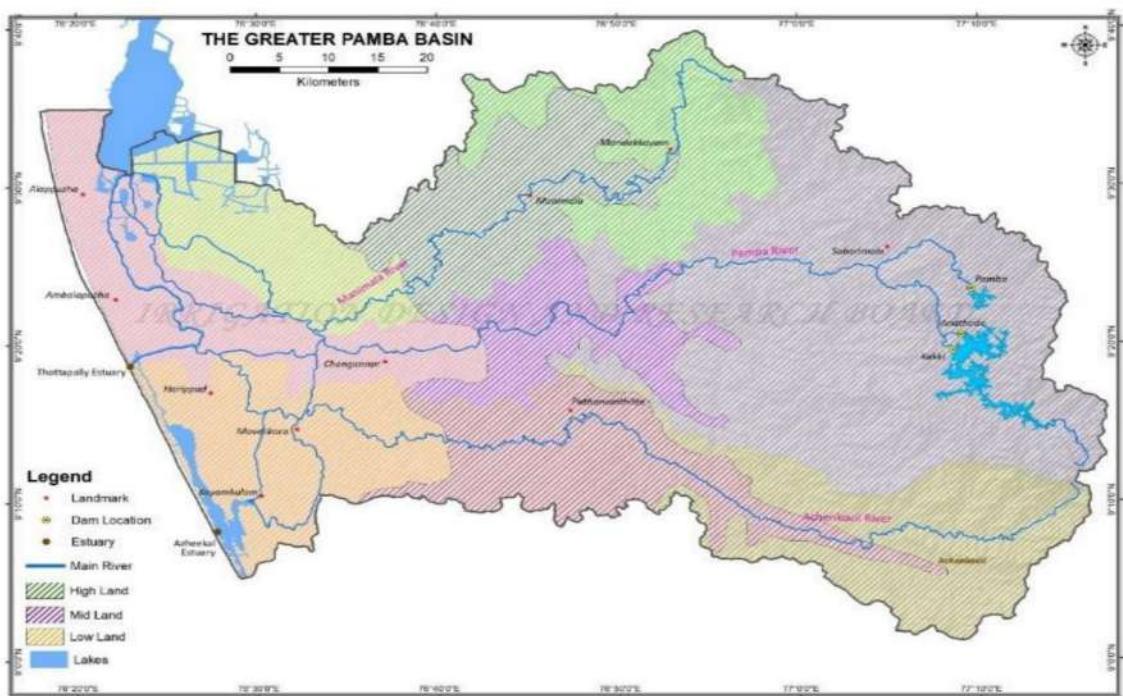
Figure 2.2: A map showing the Highlands, Midlands and Lowlands of Greater Pampa River Basin.

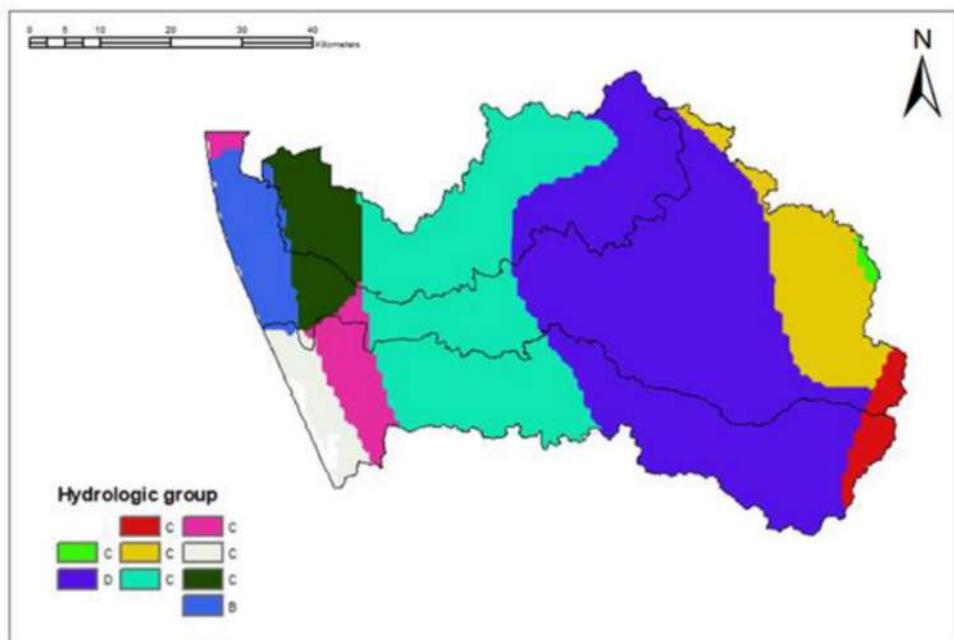
the steep terrain and slower infiltration rates due to denser soils and natural vegetation. The midland regions show Group C soils, indicating moderate infiltration and runoff potential while the lowland regions near the western part exhibit Group C soils. Group B soil is present only in a small region south of the Vembanad Lake. Group B soils are typically characterized by relatively higher infiltration rates and lower runoff potential compared to Groups C and D. These soils are often sandy loam or silty loam in texture, which allows for more efficient percolation and groundwater recharge while reducing the volume of surface runoff. In areas where Group B soils are present, water is more likely to infiltrate into the soil profile, supporting both plant growth and sustainable water availability.

Figure 2.8: Soil map of the study area (Source: The FAO Soil Map (HWSD))

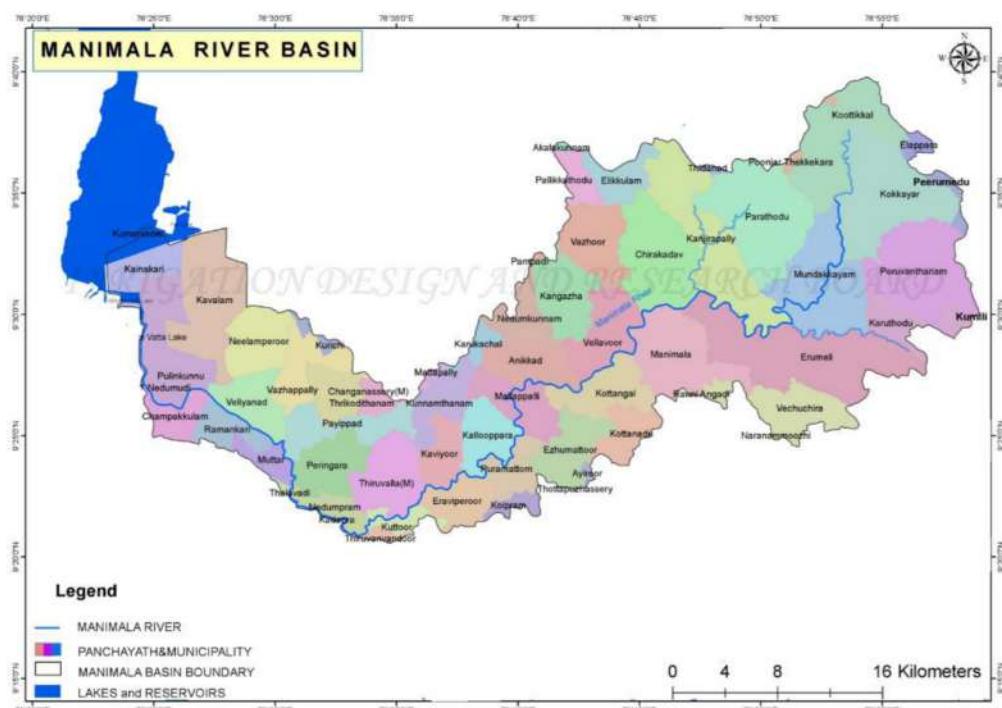
Figure 2.11: Map Showing the extend of Manimala River Basin

The Manimala River is enriched by tributaries such as Puthanpalam Aar and Karimpa Ar, which contribute to its flow and sustain biodiversity. While the river does not host major reservoirs, smaller check dams and irrigation structures regulate its flow to meet agricultural demands. However, challenges such as sand mining, pollution, and urban encroachments threaten its ecological health. Sustainable practices focusing on afforestation, pollution control, and resource management are critical to preserving the Manimala River's role in supporting Kerala's environmental and socio-economic-systems.

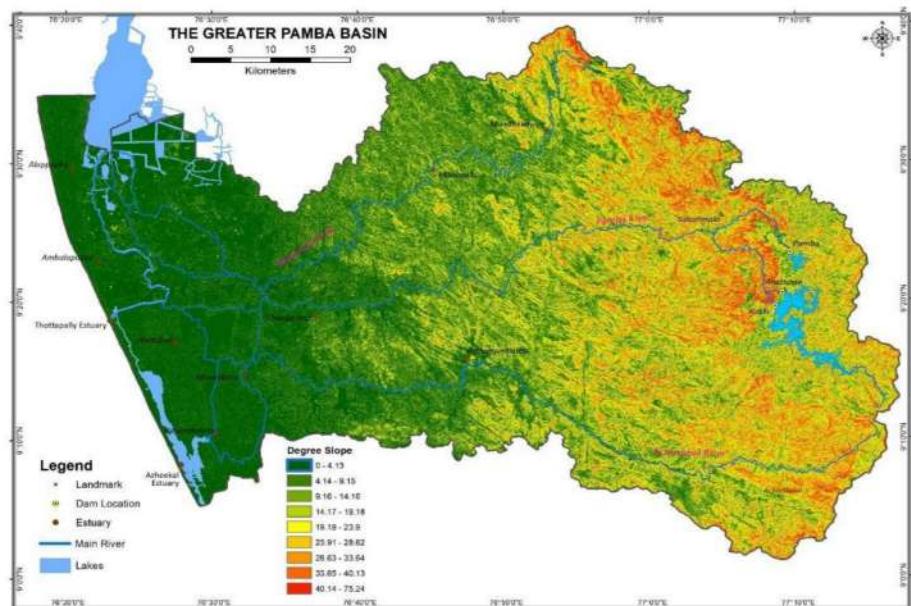
Figure 2.15: Slope characteristics in the Greater Pamba basin

Figure 2.15 shows the slope characteristics of Greater Pamba River basin. Basin relief characteristics of basin are indicative of young stages of geomorphic development and huge potentiality for further erosion. The abrupt changes of basin relief in mountain plain conjunction of Pamba Manimala and Achankovil river basin are indicative of prone to geomorphological hazards. Relief ratio denotes the ratio between total reliefs to the length of the principal drainage line (Lindsay and Seibert 2013). The value depends upon different factors of areal and relief characteristics of basin. The relief ratio, an indicator of the basin's steepness, is highest in the Achankovil basin, having the value 20.85, while the Manimala basin has the value 19.47, and the Pamba basin has the lowest value, 17.36. The higher relief ratio in Achankovil suggests steeper slopes, which may lead to quicker runoff and higher sediment transport. The ruggedness number, which combines relief and drainage density to describe the terrain's ruggedness, is highest in the Pamba basin, with the value 1.75, followed by the Achankovil basin, having the value 1.69, and the Manimala basin, where the value is 1.27. A higher ruggedness number indicates a more uneven and dissected terrain, implying higher runoff velocity and erosion potential in the Pamba and Achankovil basins compared to the Manimala basin. Table 2.13 shows the relief parameters calculate for the high land, midland and lowland regions of the basin.

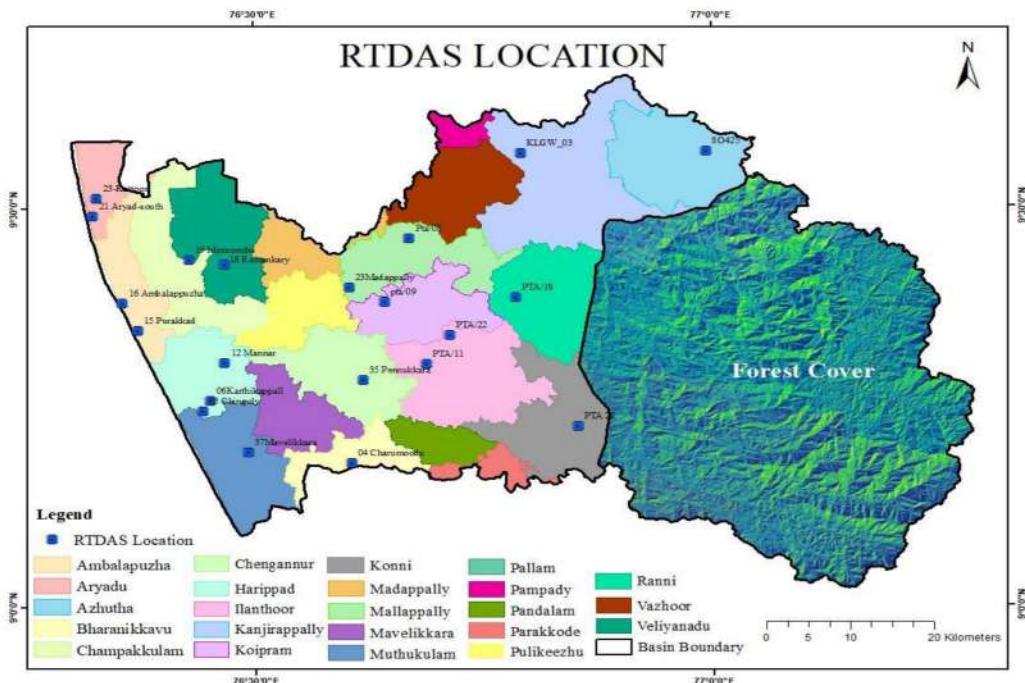
To monitor micro groundwater changes in the basin, the groundwater department has established 21 RTDAS (Real Time Data Acquisition Stations). The digital water level recorders fitted with a telemetry system have capability to record 4 groundwater level data in 6 hours intervals. These monitoring stations will be useful to understand the daily micro water level fluctuations in response to extreme climatic events and recharge and discharge conditions of the basin. The high frequency data would also be useful to understand the coastal changes, occurrence of drought and urban flooding which is prevalent in many parts of the basin. The map showing the RTDAS locations is given in the Figure 2.18.

Figure 2.18: Average Groundwater Level Map of the Basin

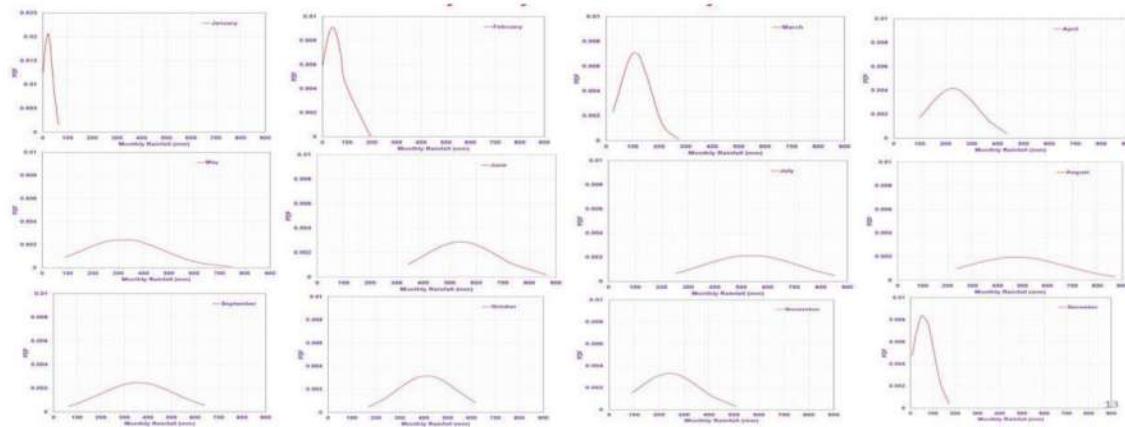
Monthly Rainfall Distribution: The probability density function (PDF) serves as a valuable tool for understanding the distribution of monthly rainfall. By plotting the PDF against total rainfall for each month, researchers can discern the probability of different rainfall amounts occurring. In this context, a leptokurtic distribution indicates a higher likelihood of extreme values, while positive skewness suggests an asymmetry with a longer tail on the right side, favoring higher rainfall values.

Figure 3.1: Probability density function (PDF) plotted against total rainfall

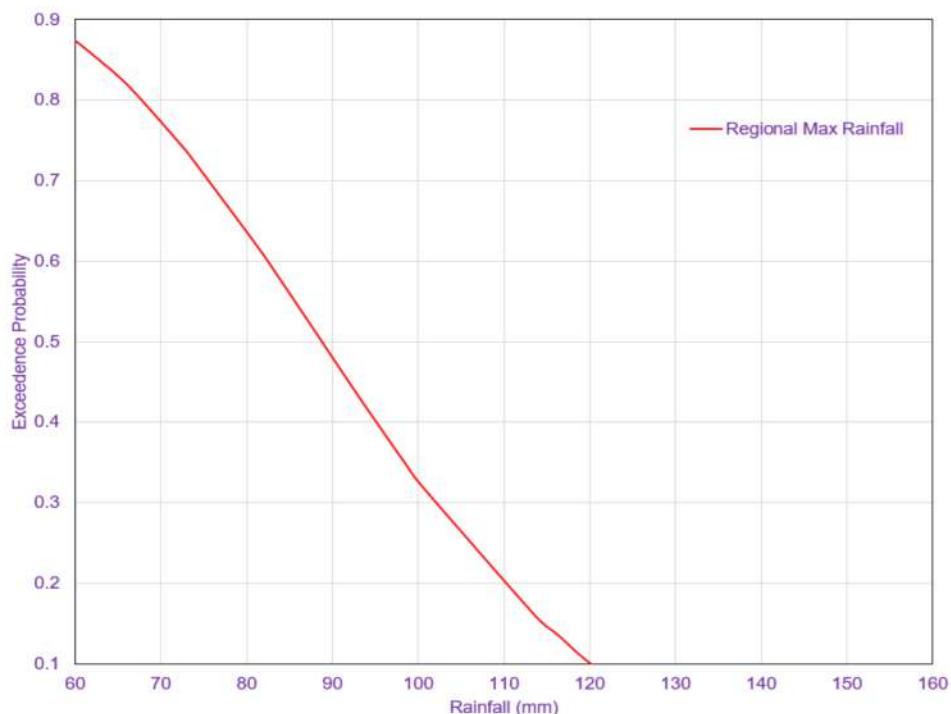
Adaptive Strategies: The observed cyclic pattern of maximum daily rainfall highlights the need for adaptive strategies in the Pamba Basin. Infrastructure planning, flood preparedness, and sustainable water management practices should consider the dynamic nature of rainfall patterns. Adaptive measures could include the development of early warning systems, resilient infrastructure, and community engagement to enhance preparedness for extreme rainfall events.

Figure 3.4: Exceedance Probability

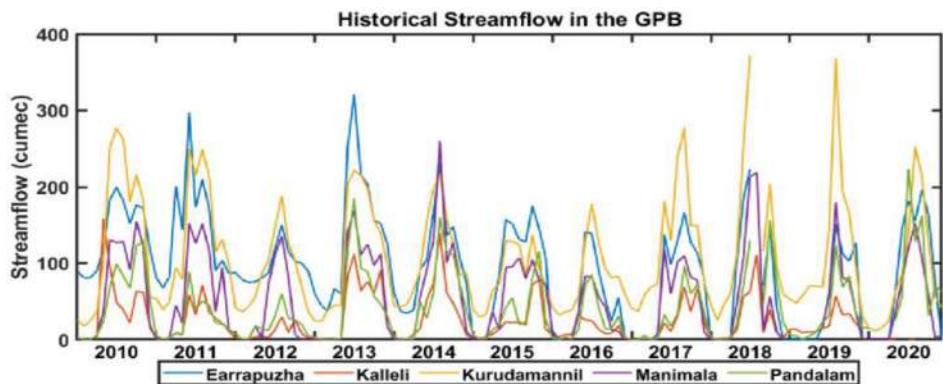
Five major gauging stations have been identified on the streams of Greater Pamba Basin, where continuous high-quality observations are available over the recent period (2010 – 2020). The Manimala gauging station records streamflow for the Manimala River, Kurdamannil and Earrapuzha stations record the flow in the Pamba river and the Kalleli and Pandalam stations monitor flow in the Achankovil river. The flow measured are shown in Figure 3.5. The Manimala stream is seen to dry in the summer months. Extreme flow events have been recorded in the years of 2018 and 2019.

Figure 3.5:Historical flow in WRD stations in Greater Pamba Basin

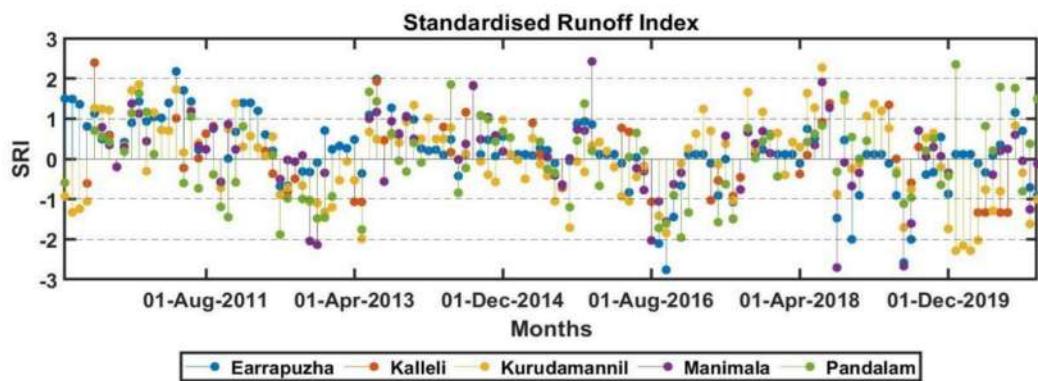
The GPB typically experiences its most severe flooding during the monsoon season, particularly in August and September, when heavy and sustained rainfall causes the rivers to overflow their banks. These floods can severely disrupt disaster relief and management efforts, leading to significant damage to homes, infrastructure, and agricultural lands. Kerala, in recent years, has faced catastrophic flooding events, with the 2018 flood being one of the worst in the state's history, highlighting the region's vulnerability to such extreme events. The extreme events in the catchment was studied using the Standardized Runoff Index (SRI), which compares monthly runoff with historical runoff to identify events that significantly vary from the historical normal (Figure 3.6). SRI values over 2 indicate extreme water excess events, while values below -2 indicate significant water scarcity events. Both extreme wet and dry events are observed in the data indicating the vulnerability of the catchment to climate extremes, which can get exacerbated in the future with climate change.

Figure 3.6:Extreme events in GPB analysed using SRI for the WRD gauges

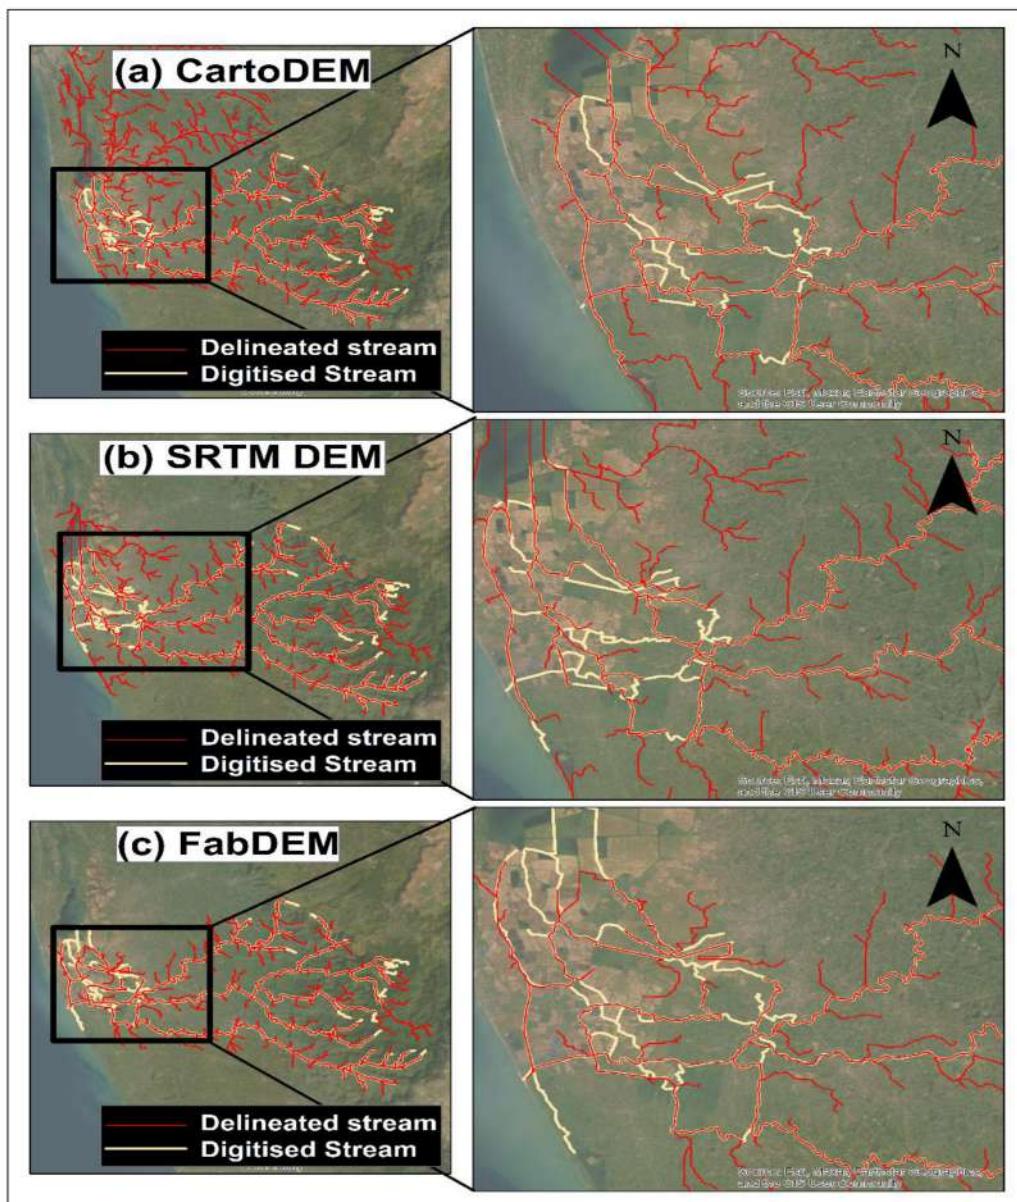
By comparing the stream network delineated from each DEM against the actual natural river network, it was confirmed that FabDEM's resolution and processing methodology provided a more detailed and reliable representation, enabling enhanced hydrological modelling and better decision-making processes for sustainable watershed management. This analysis underscores the critical role of high-resolution and accurate DEMs in capturing hydrological features, particularly in regions with complex geomorphologies, thereby supporting robust and precise hydrological and environmental assessments.

Figure 3.10: Streams delineated for the GPB using different DEM data

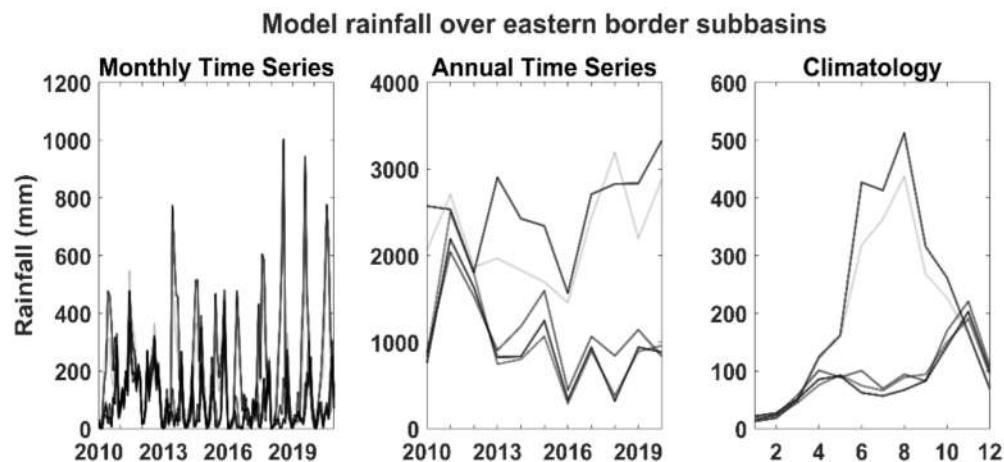
After setting up the basin in the SWAT model, the historical climate data is added as weather input into the model. Historical daily rainfall, daily maximum temperature and daily minimum temperature data from IMD were added to the model. The model run with raw climate data indicate significant underestimation of flow in the eastern subbasins in the GPB. The IMD gridded data input to the model was analysed to identify the source of the uncertainty. The rainfall climatology of subbasins on the windward side of the Western Ghats mountain ranges shows characteristics similar to the rain gauge stations on the leeward side of the Western Ghats mountain ranges, with peak rainfall during the North-East monsoon months (Figure 3.11). To alleviate this issue, the IMD rainfall grids on the Western Ghats mountain ranges were removed, and the grids just west of the removed grids were reassigned to the eastern subbasins. The effect of reassignment was analysed for flow at the Manimala gauge, and the NSE was seen to increase from 0.57 to 0.67.

Figure 3.11: IMD Gridded Rainfall over the eastern subbasins in the model

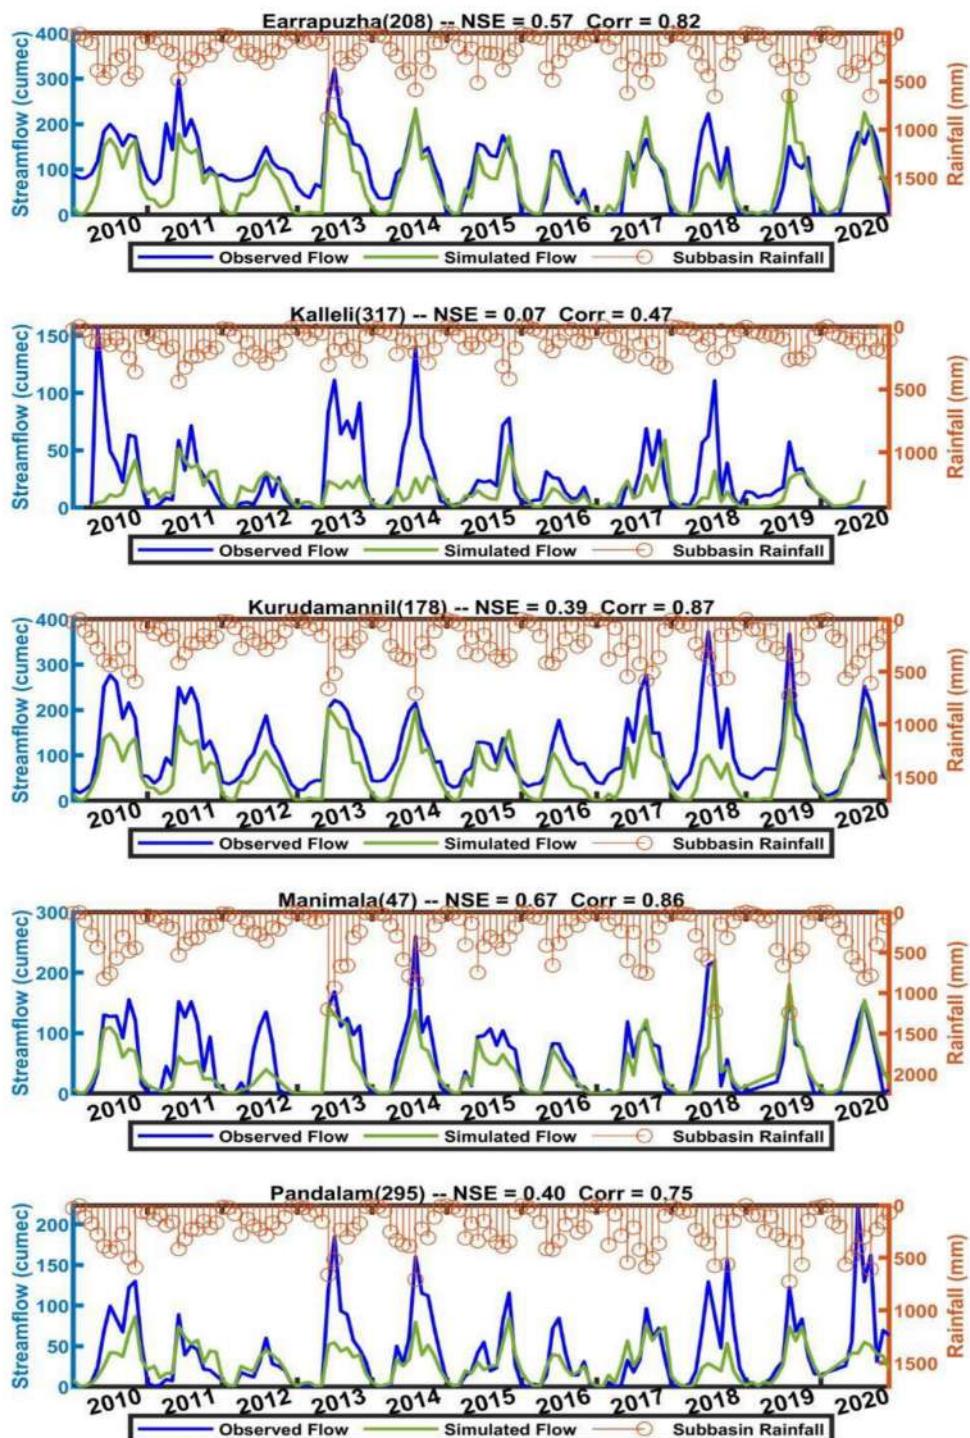
Figure 3.12: Time series plots of simulated flows by the uncalibrated model vs observed flows at the IDRB gauges

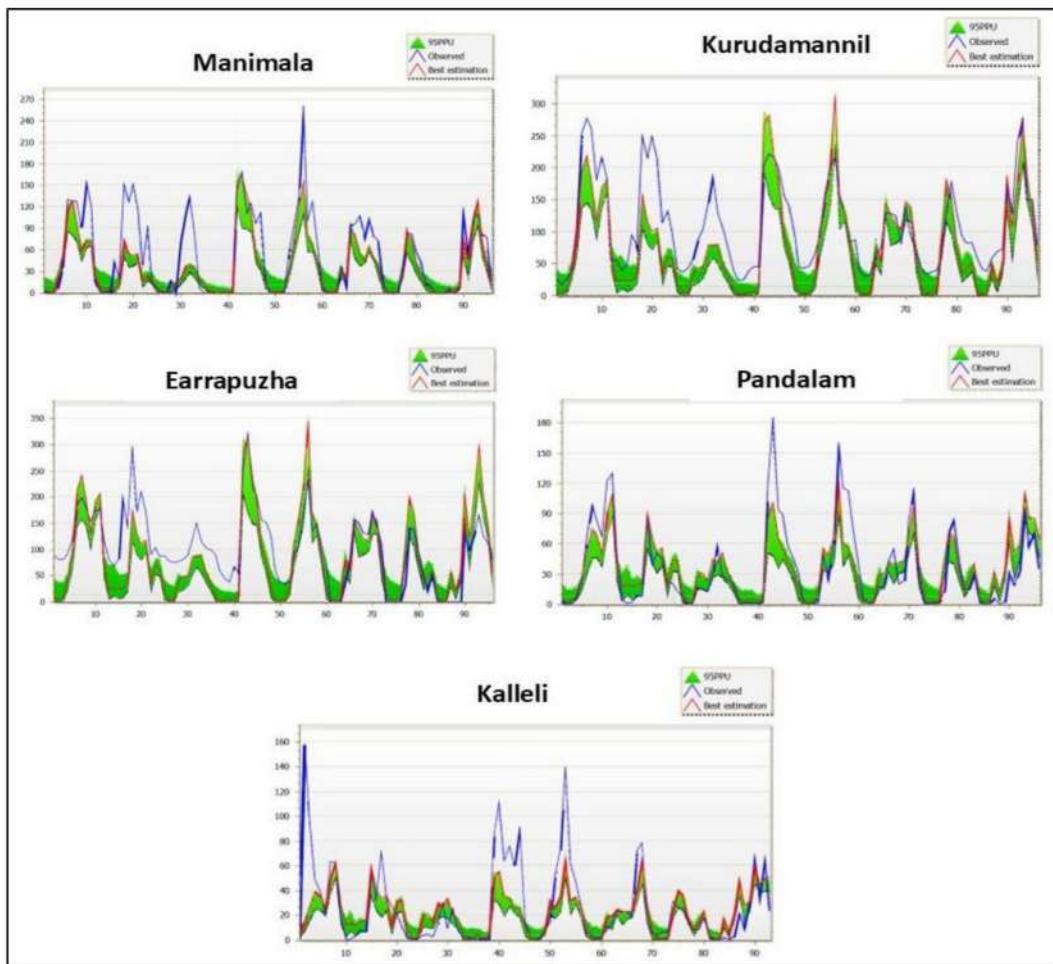
Following sensitivity analysis, the top 15 parameters were selected for calibration. The SWAT model calibration was performed using SWAT-CUP, a calibration and uncertainty analysis tool, employing the SUFI-2 (Sequential Uncertainty Fitting, Version 2) algorithm. This process involved iterative adjustments of sensitive parameters to minimise discrepancies between observed and simulated outputs while simultaneously assessing prediction uncertainty. Parameters such as the SCS Curve Number (CN2), groundwater threshold depth (GWQMN), etc. were identified as critical through sensitivity analysis and calibrated within realistic ranges to optimise the model's performance. Calibration focused on replicating streamflow dynamics, including seasonal variations, peak flows, and baseflows, using observed data over the defined calibration period. The Figure 3.13 and Table 3.2 are presented to show the calibration results at various locations in the GPB. The 95 Percent Prediction Uncertainty (95PPU) band is presented in the Figure 3.13 along with the observed data at the IDRDB Gauging stations. The 95PPU provides an understanding of the parameter uncertainty in the calibration procedure.

Figure 3.13: Comparison of flows simulated by calibrated model at the IDRDB gauging stations

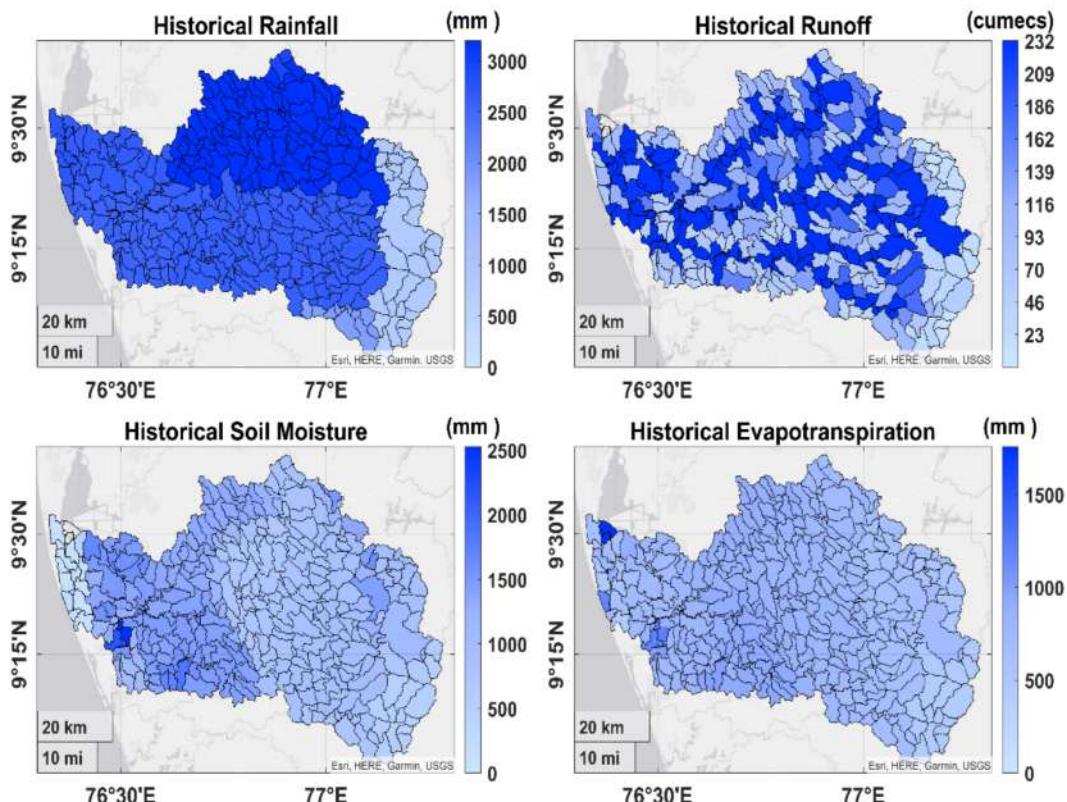
The runoff in the GPB is highest in subbasins where the streams are present. The subbasins with streams are visible particularly in the downstream region. Streamflow is highest in the Pamba river compared to the Manimala and Achankovil streams. Low runoff in the majority of the catchment indicates poor surface water availability, which may cause challenges in irrigation and drinking water supply. The spatial variability in soil moisture shows clear patterns, with values ranging between 300 mm and 2000 mm. Western central regions show higher soil moisture levels, likely due to higher rainfall and favourable soil characteristics. Eastern areas, with lower rainfall, exhibit reduced soil moisture. Higher soil moisture in the western central subbasins suggests better agricultural potential in the region, while the southern and south-eastern subbasins may experience water stress for crop production. ET is consistently high across the catchment, with values ranging between 400 mm and 1700 mm. Higher ET rates are concentrated in the eastern subbasins, driven by higher temperatures and lower soil moisture retention. High ET rates indicate a significant loss of water to the atmosphere, reducing water availability for runoff and soil storage. South-eastern regions are particularly vulnerable due to the combined effects of high ET and low rainfall.

Figure 3.14: Historical water availability in the GBP. Spatial variation in Rainfall, Runoff, Soil Moisture and Evapotranspiration

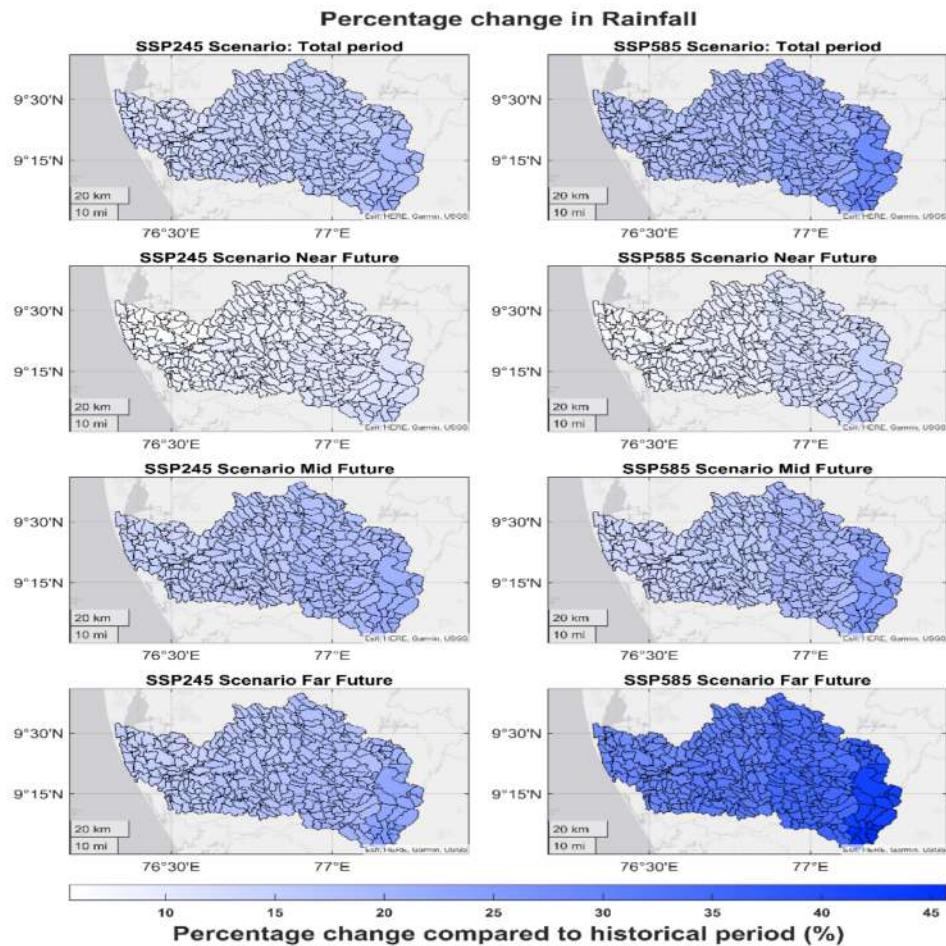
The rainfall in GPB show an increasing trend, as is seen in Figure 3.16. The rainfall is increasing by about 28 to 48% from the historical period across the catchment. The increase in rainfall is higher in the SSP245 scenario compared to the SSP585 scenario. The south-eastern region of the GPB, where the historical rainfall is observed to be the lowest shows the most relative change in the future. The least change is seen in the northern part of the catchment. The spatial pattern of change in rainfall across the GPB is similar across the scenarios, and across the different future time periods considered, indicating a wet future in the catchment. The percentage change is higher in the near future period and reduces in the far future. These changes suggest potential shifts in water availability, with implications for hydrological processes, agricultural practices, and flood risk management in the catchment. The increasing trend in rainfall across the GPB, particularly in south-eastern regions, can be attributed to climate change-induced intensification of the hydrological cycle. Higher temperatures increase atmospheric moisture-holding capacity, leading to more intense and frequent precipitation events. The larger relative increases in historically drier areas may result from local topographic and atmospheric feedback, as well as shifts in monsoonal circulation patterns.

Figure 3.16: Projected percentage change in rainfall over the GPB across different climate scenarios

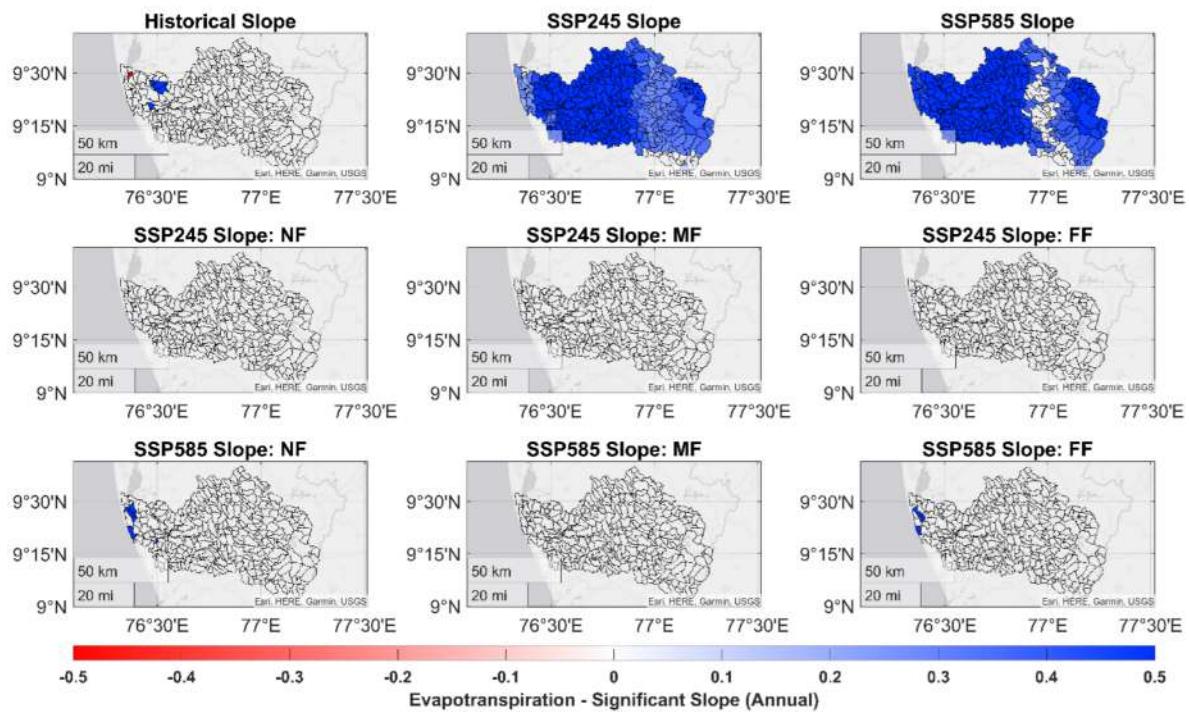
The projected ET in the GPB exhibits significant increasing trends, reflecting increased atmospheric demand for water (Figure 3.25). Over the historical period, very few subbasins exhibit any statistically significant trends in ET. In the future period, most of the subbasins in GPB exhibit significant trends over the long-term. Over short-term period, none of the subbasins exhibit any significant trends in the future indicating long term variation in ET, driven by climate change. Increasing ET trends suggest rising water demand and greater pressure on water resources, particularly in the eastern regions. This may exacerbate water stress in areas already facing moisture deficits.

Figure 3.25: Spatial distribution of long-term trends in evapotranspiration in the GPB

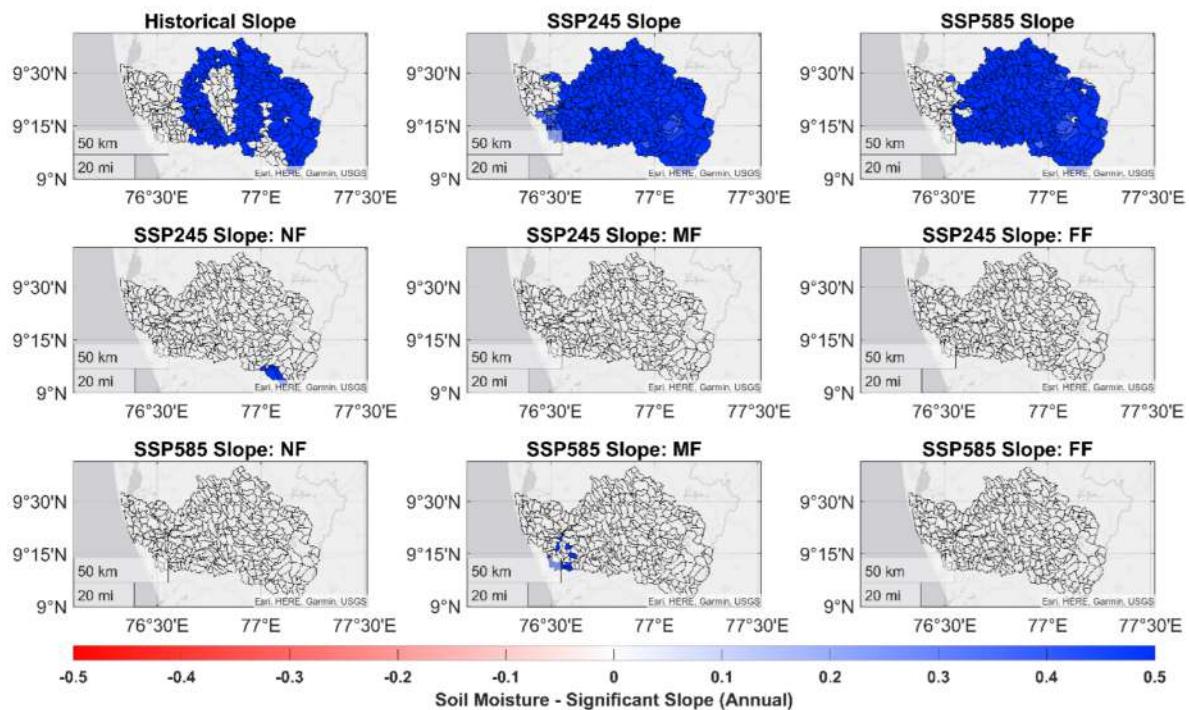
Statistically significant increasing slope is seen in the soil moisture for central and eastern subbasins in both historical and future periods (Figure 3.26). The downstream regions of the catchment show no statistically significant slopes in any of the periods considered. Absence of trend in these subbasins does not mean that the soil moisture does not change in the future, just that the variation is not monotonous. The short-term future periods considered show little to no subbasins with statistically significant trends, indicating only long-term variations in the soil moisture in GPB. The spatial variability in slope indicates that the changes in soil moisture is driven by complex interactions of multiple factors and cannot be attributed to climate change alone.

Figure 3.26: Spatial distribution of long-term trends in soil moisture over the GPB

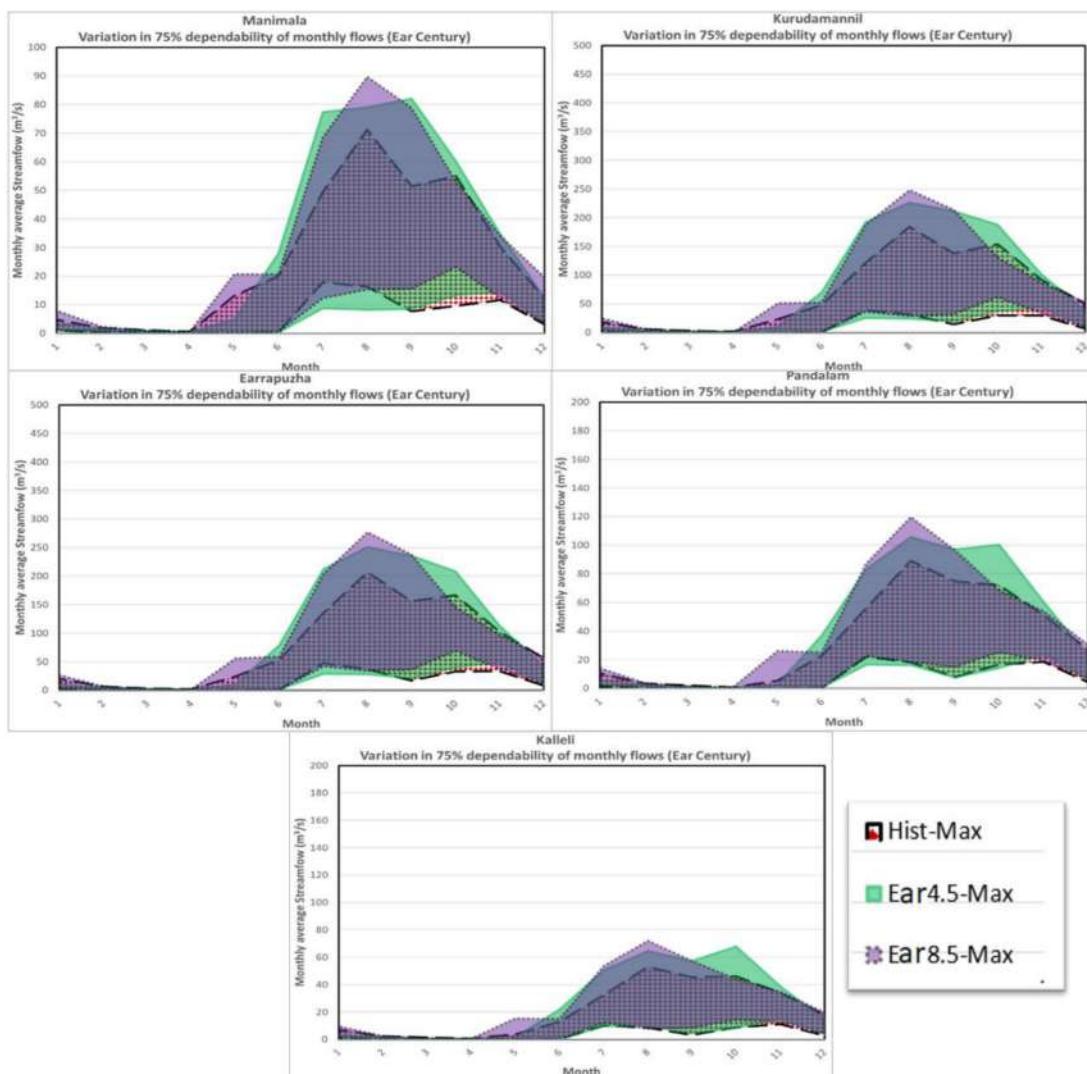
The Figure 3.27 illustrate the projected variations in 75% dependable monthly streamflows for different locations (Manimala, Kurudamannil, Earrapuzha, Pandalam, and Kalleli) in the Pamba River Basin under historical conditions and future climate scenarios (Early 4.5 and Early 8.5) for the period 2025 - 2047.

Figure 3.27: Variation of 75% dependable monthly streamflows (early-century)

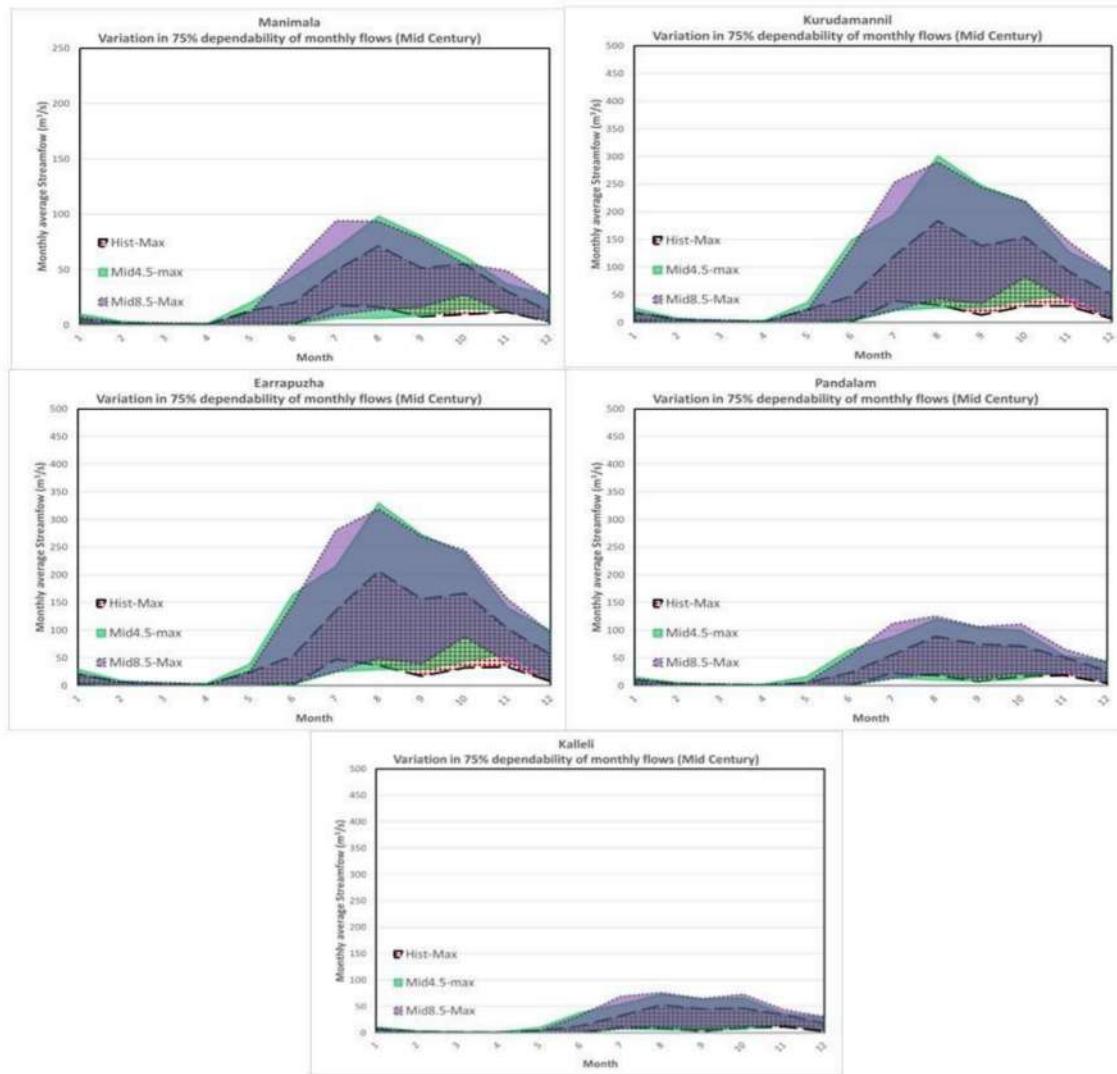
Figure 3.28 depict variations in the 75% dependability of monthly streamflows across five different locations in the GPB: Manimala, Kurudamannil, Earrapuzha, Pandalam, and Kalleli. These analyses consider historical data (Hist-Max) and mid-century projections under two climate change scenarios, RCP 4.5 (Mid4.5-Max) and RCP 8.5 (Mid8.5-Max). The analysis highlights the temporal and spatial variability in stream flows under changing climatic conditions.

Figure 3.28: Variation of 75% dependable monthly streamflows (mid-century)

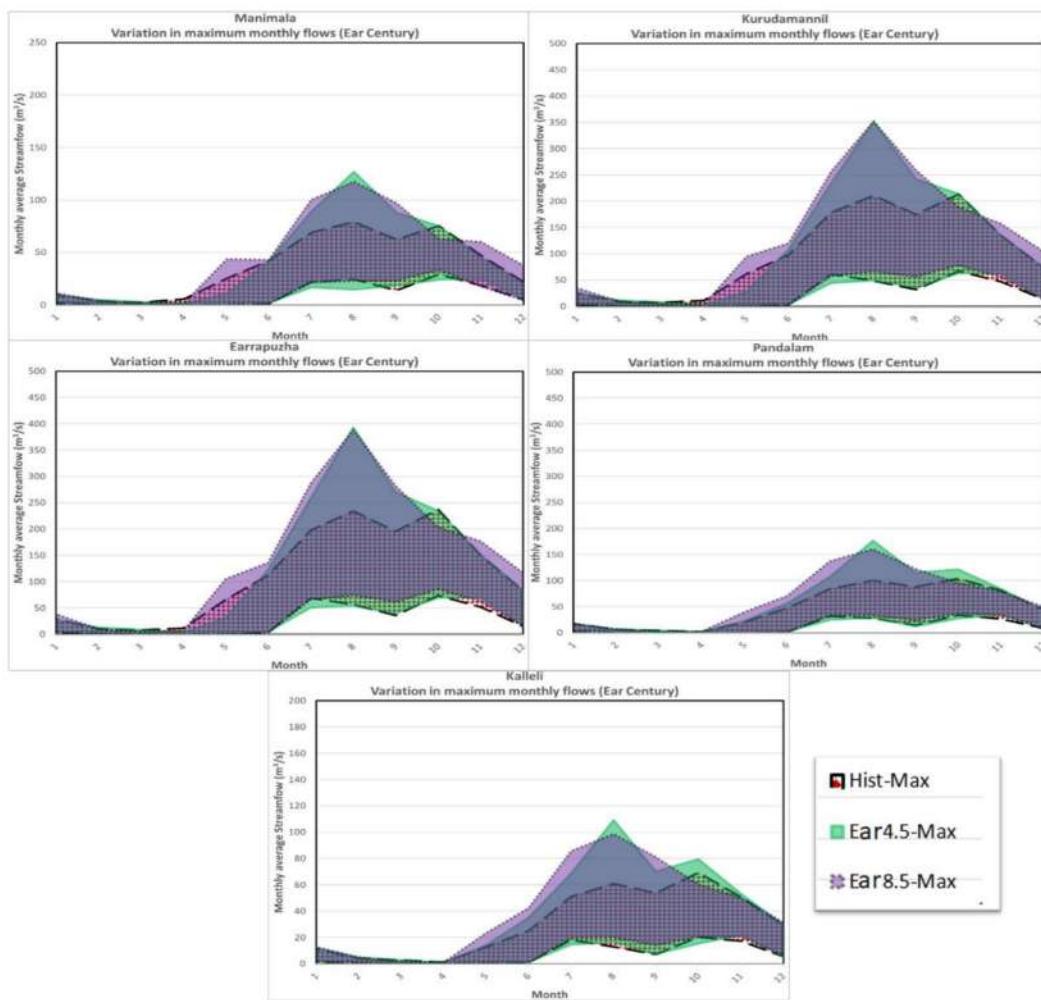
- Increased Peak Flows in Future Scenarios: Both RCP 4.5 and RCP 8.5 scenarios project significant increases in peak monsoon flows (June to September) compared to historical conditions. The RCP 8.5 scenario consistently shows higher maximum flows and greater variability compared to RCP 4.5, reflecting the amplified effects of high-emission scenarios.
- Dry-Season Stability: Maximum flows during the dry season (January to May) remain low across all locations and scenarios, with little visible impact from climate change during these months.
- Interannual Variability: Shaded regions indicating variability are more pronounced under RCP 8.5, especially for peak flows, highlighting increased uncertainty under high-emission conditions.

Figure 3.30: Variation of maximum monthly stream flows (early-century)

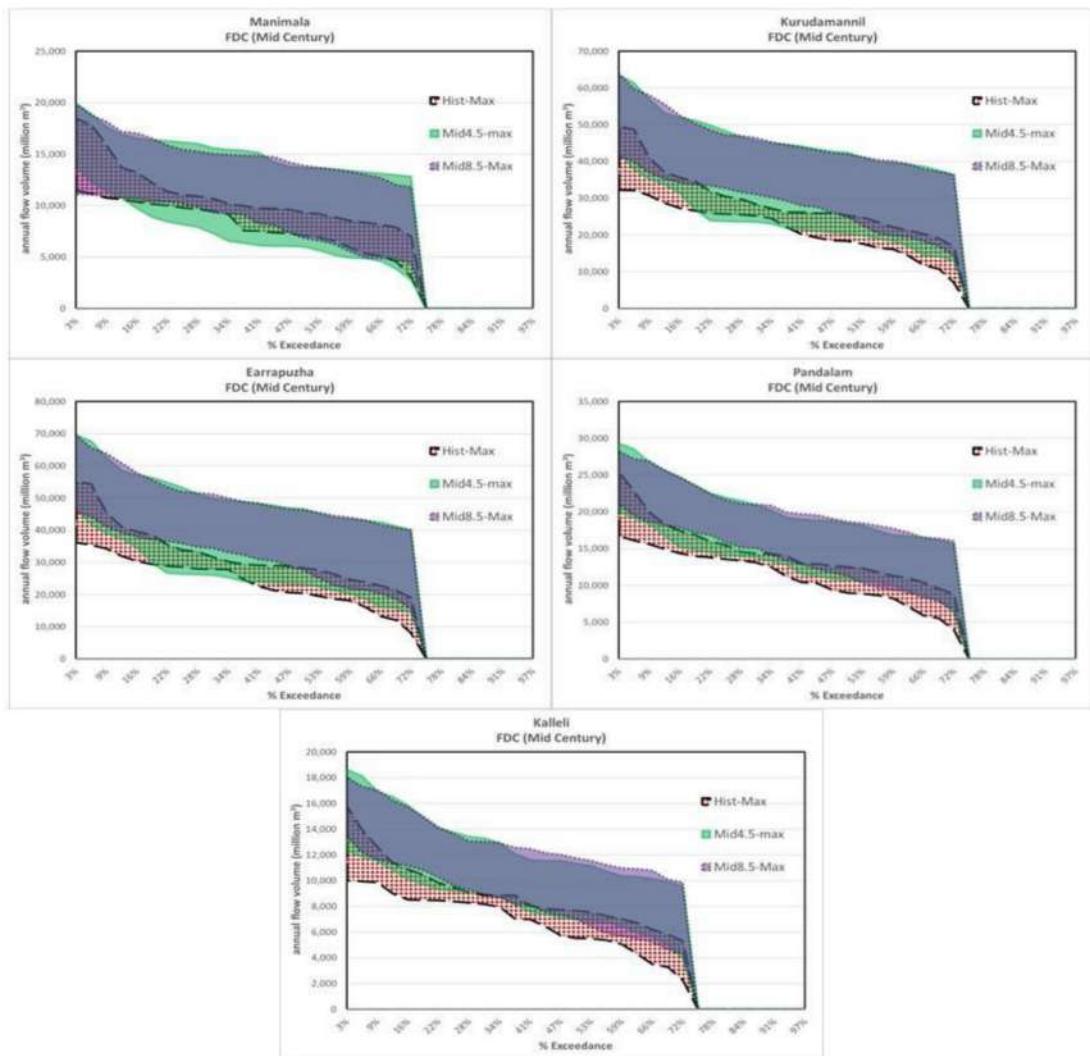
- The FDCs display a clear reduction in low flows (high exceedance probabilities) and an increase in high flows (low exceedance probabilities) under future climate scenarios compared to historical conditions.
- Greater variability is observed under RCP 8.5 (Mid8.5-Max) compared to RCP 4.5 (Mid4.5-Max), especially in the higher flow regime (low exceedance).

Figure 3.34: Flow duration curves at control locations (mid-century)
