Water Resources Department- Resilient Kerala Program- Integrated River Basin Management Plan for Greater Pamba Basin- Approved- Orders issued.

G.O.(Rt)No.504/2025/WRD Dated, Thiruvananthapuram, 22-05-2025

The Integrated River Basin Management (IRBM) Plan for the Greater Pamba Basin is a comprehensive framework designed to address Kerala's pressing challenges of flooding, water insecurity, and ecological degradation. Anchored in scientific analysis and participatory governance, the plan responds to the catastrophic 2018 Kerala floods, which caused unprecedented devastation, including loss of lives, destruction of crops, and critical damage to water infrastructure. The floods underscored systemic vulnerabilities, such as silt-clogged irrigation canals, collapsed hydraulic structures (sluice gates, check dams), and overwhelmed urban drainage systems. Coastal protection breaches also led to saltwater intrusion in the ecologically sensitive Vembanad Lake. These impacts catalysed the state's commitment to rebuilding sustainably through Integrated Water Resources Management (IWRM), guided by the "Navakeralam" vision of equitable development.

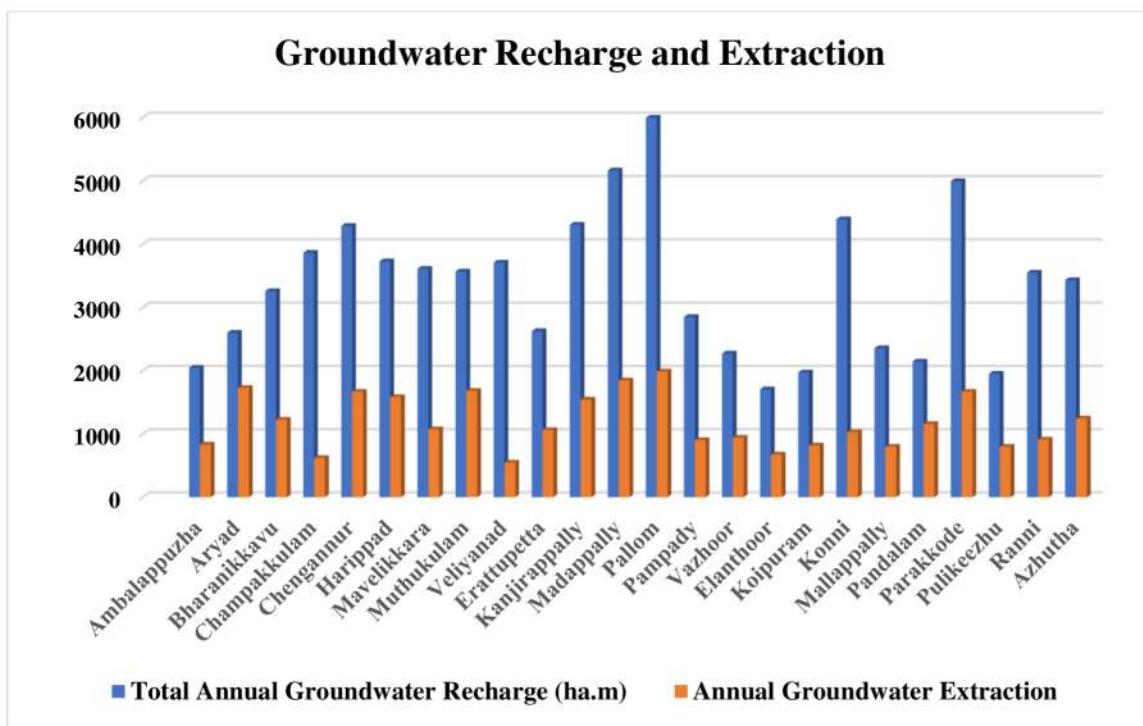
The total annual groundwater recharge varies across different blocks, ranging from 1705.63 ha.m (Elanthoor) to 5997.97 ha.m (Pallom). This variation is influenced by factors such as rainfall, geological formations, and land use patterns. On the other hand, annual groundwater extraction varies from as low as 546.73 ha.m (Veliyanad) to as high as 1987.83 ha.m (Pallom). The availability of groundwater is estimated as per the GEC norms 2017 which was based on the annual groundwater recharge in the area and also based on the total draft for various purposes. From the analysis it is found that some blocks falls within the basin experience significant groundwater usage, likely due to irrigation, industrial and domestic demands. The total available groundwater and annual groundwater extraction is given in the Figure 3.36 below.

Figure 3.36: Graph representing Groundwater recharge and extraction (in ha.m)

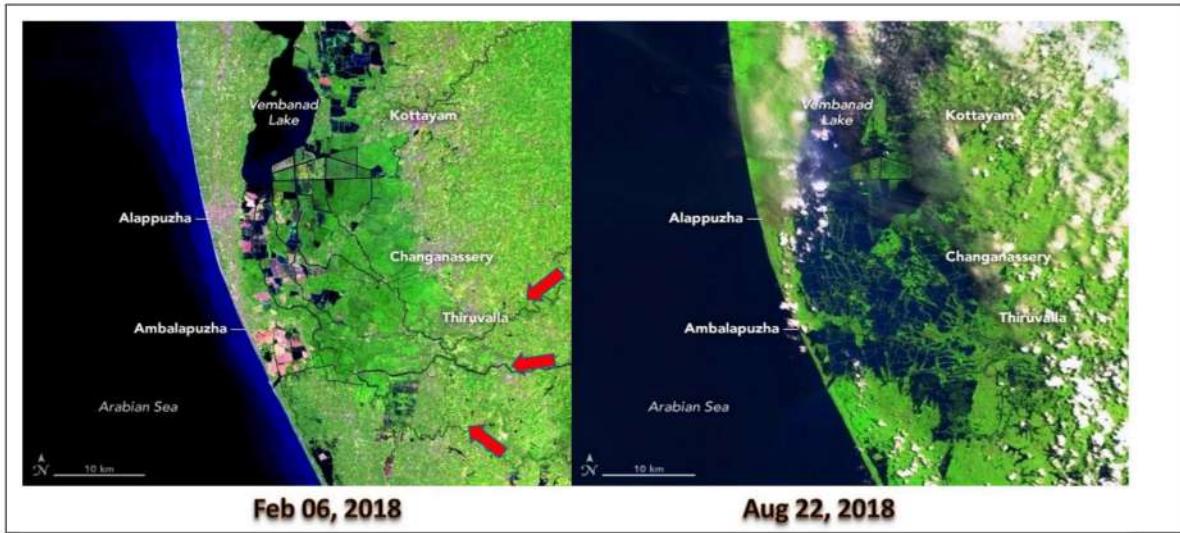
Figure 5.3: Satellite images showing before and after flood 2018 in the Kuttanad Region

Figure 5.3 presents satellite images of the Kuttanad region before and after the flood, highlighting the severe impact of the disaster. The flooding was extensive, with water having no clear path to recede.

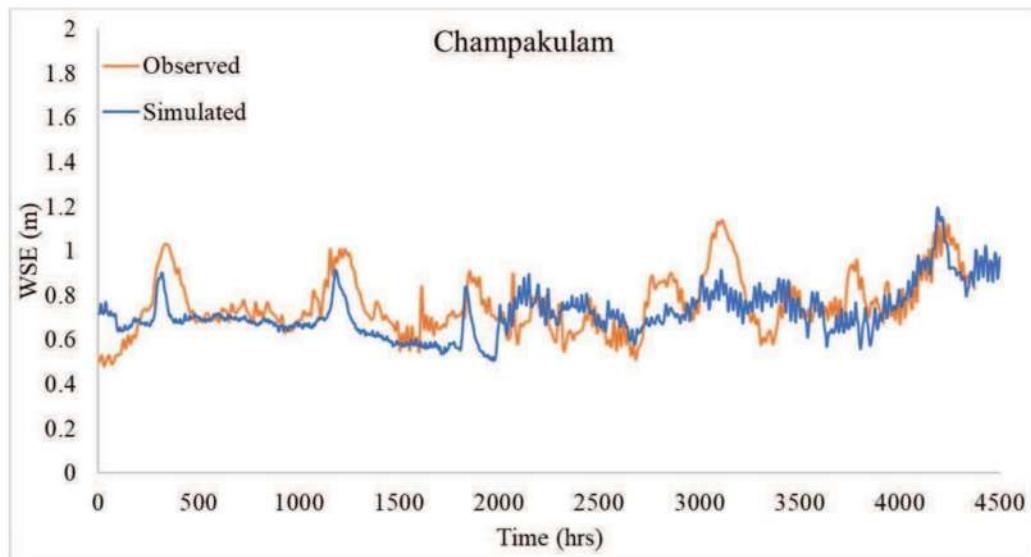
Figure 5.12: Comparison of simulated and observed water levels at Champakulam.

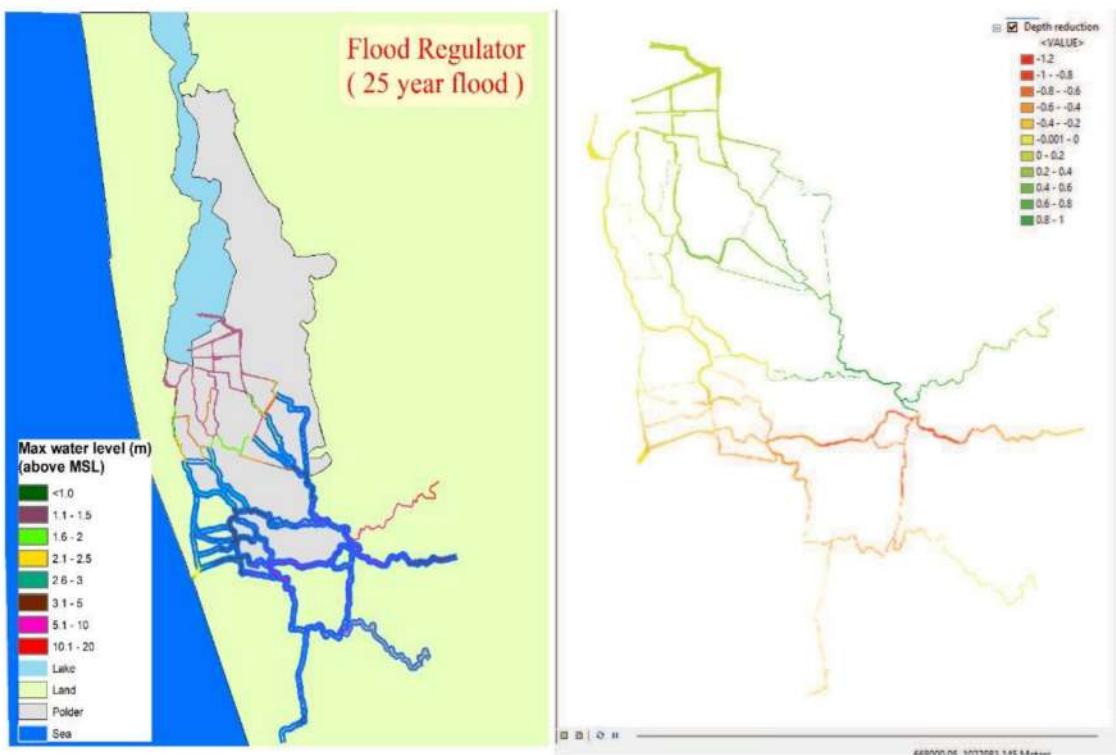
Figure 5.22: 25-year return period flood hydrograph – (a) channels which are likely to overflow and (b) change in water levels with the flood regulator in the Pampa River

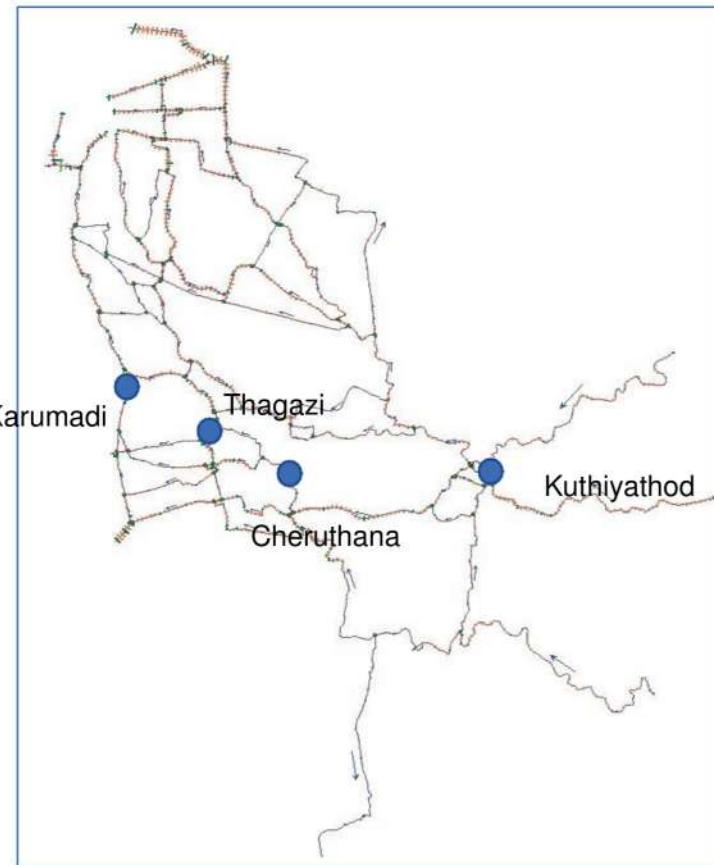
Figure 5.24: Locations of the four flood regulators at Karumadi, Thakazhy, Cheruthana, and Kuthiyathodu.

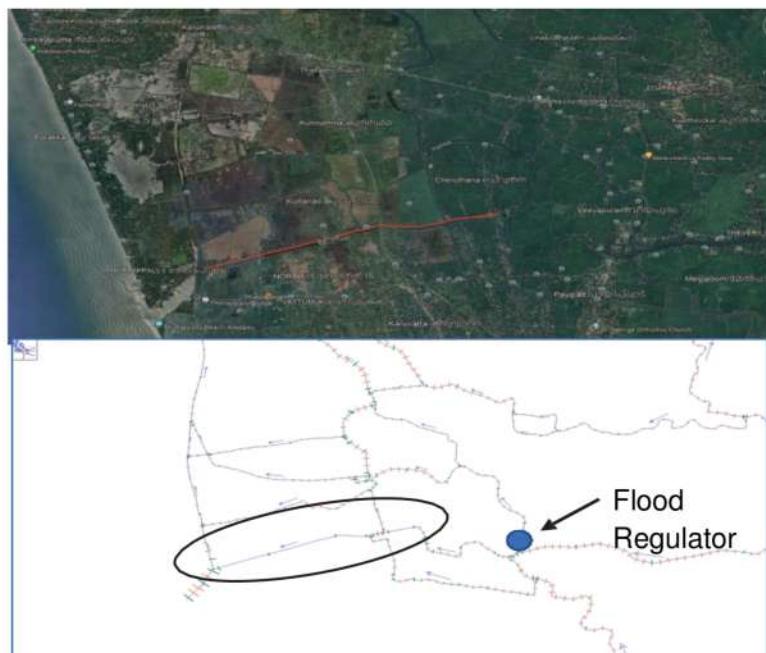
Figure 5.31:Modification of lead channel of Thottapally spillway

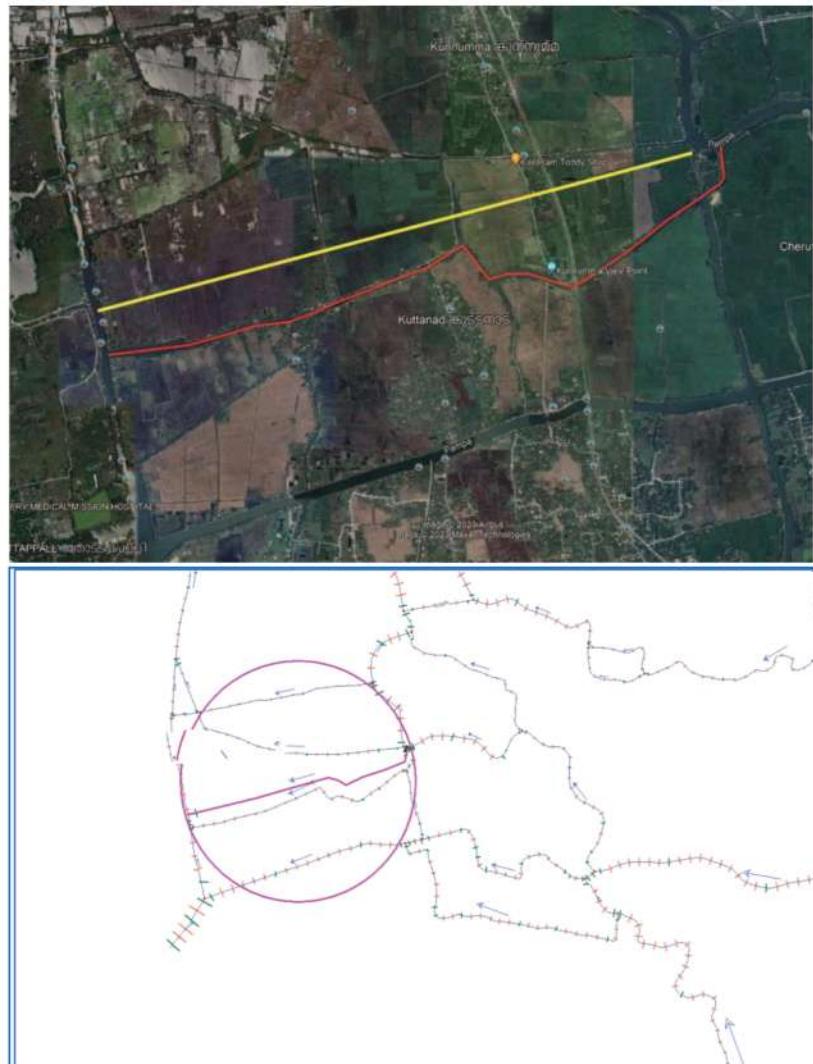
Figure 5.33: Proposal of an alternate channel parallel to Korankuzhy Thodu and the same considered in the model.

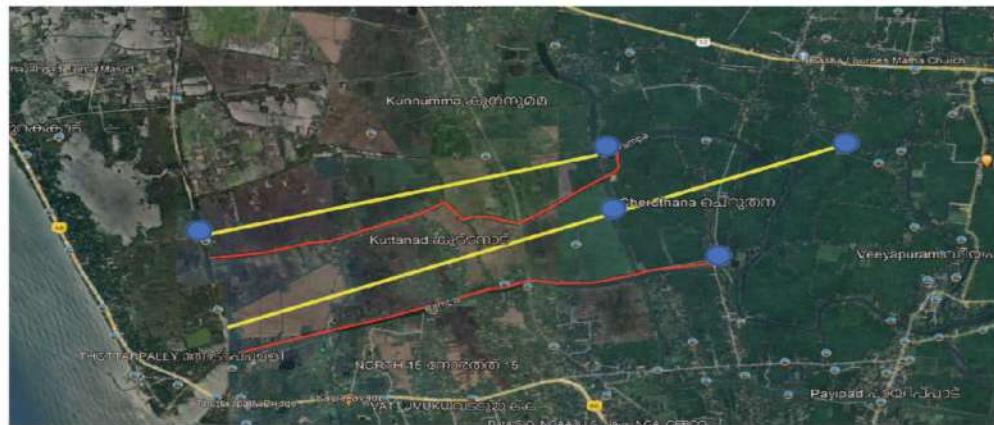
Figure 5.35: Combination of modification of existing channels and alternate channels in the numerical model
